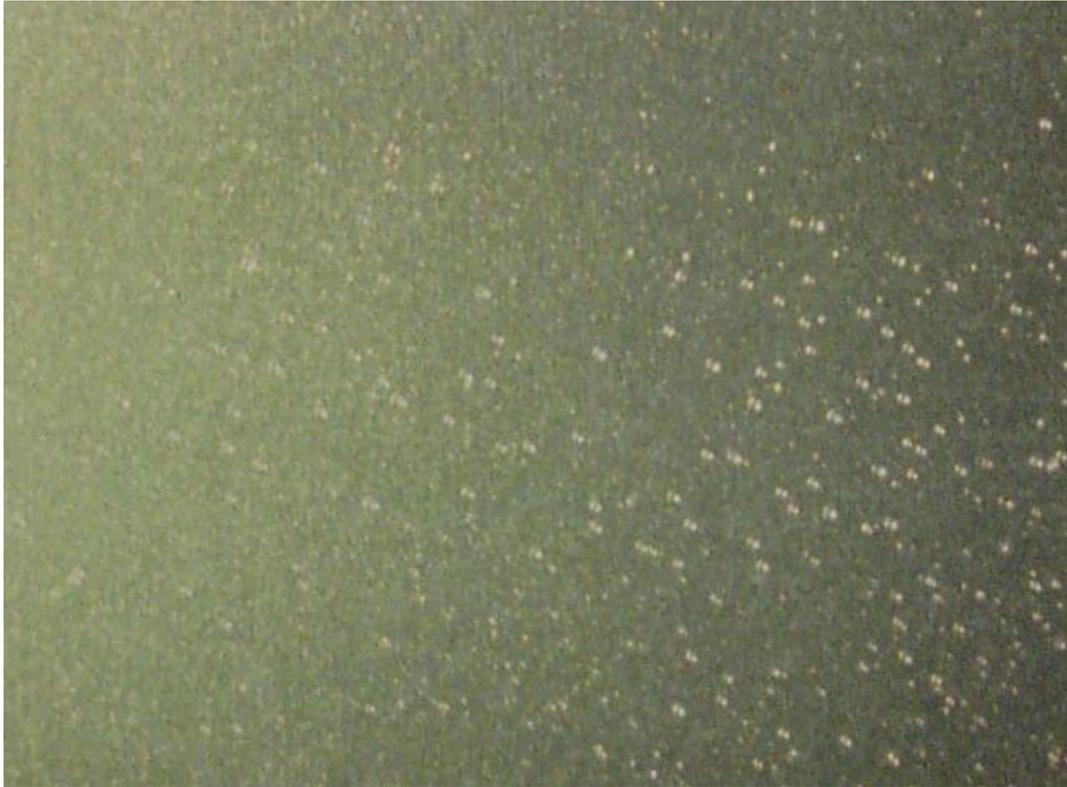
Large rounded air bubbles or blisters, usually occurring in the area of seams and boxed in corners, or over heavily filled plastic surfaces.

Air trapped beneath the paint expands, resulting in the detachment of the paint film from the substrate. This frequently results from:

- Poor application of filler, stopper or primer resulting in entrapped air.
- Poor feather edging of chipped film.
- Bridging of seams and boxed corners by the paint film.
- Porosity and air pockets in the primer due to inferior or insufficient thinner, the compressed air pressure too high, or day spraying.
- Failure to prepare and seal substrate correctly, especially when spraying GRP.
- Excessive application of heat during drying.

- Ensure correct application of filler, stopper or primer.

- Feather edges of chipped film properly.
- Avoid heavy paint application and ensure that the film penetrates into seams and boxed corners.
- Always use recommended thinner and correct spraying techniques. Apply primers in thin web films.
- Examine the substrate for porosity, especially for gel coat bubbles in GRP. Prepare and seal carefully.
- Avoid excessive application of heat during drying.

The paint must be removed to the depth of the bubble, any underlying defect remedied and the area repainted.
